Intel® Mobile Pentium® III Processor Specification Update

Release Date: March 2000

Order Number: 245306-005

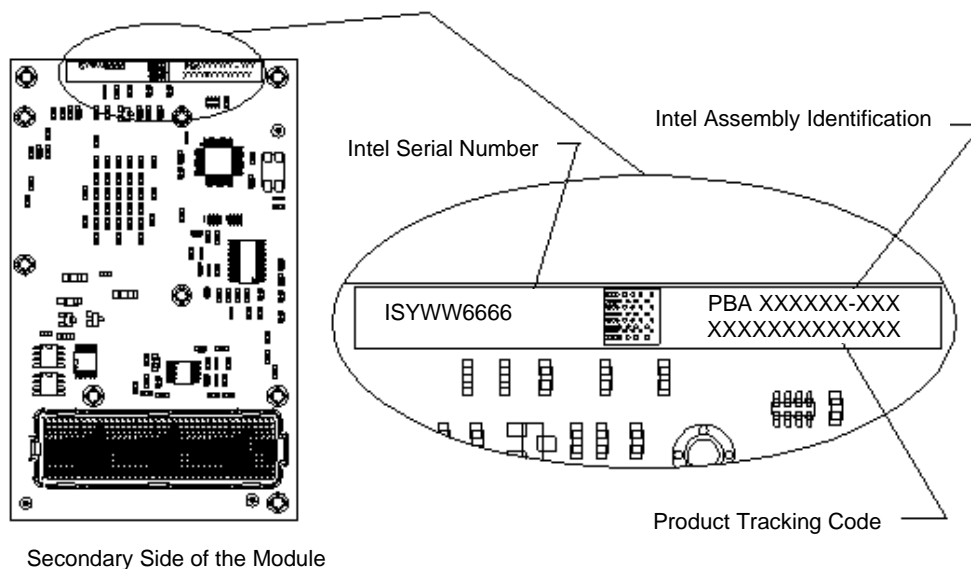
Intel Pentium III Processor Mobile Module Markings

The Product Tracking Code (PTC) determines the Intel assembly level of the module. The PTC is on the secondary side of the module and provides the following information:

- The PTC will consist of 13 characters as identified in the above example and can be broken down as follows:

- Definition:

AA	-	Processor Module = PM
B	-	Intel® Pentium® III Processor Mobile Module =L
CCC	-	Speed Identity = 450 or 500
DD	-	Cache Size = 02 (256 KB)
EEE	-	Notifiable Design Revision (Start at 001)
FF	-	Notifiable Processor Revision (Start at AA)

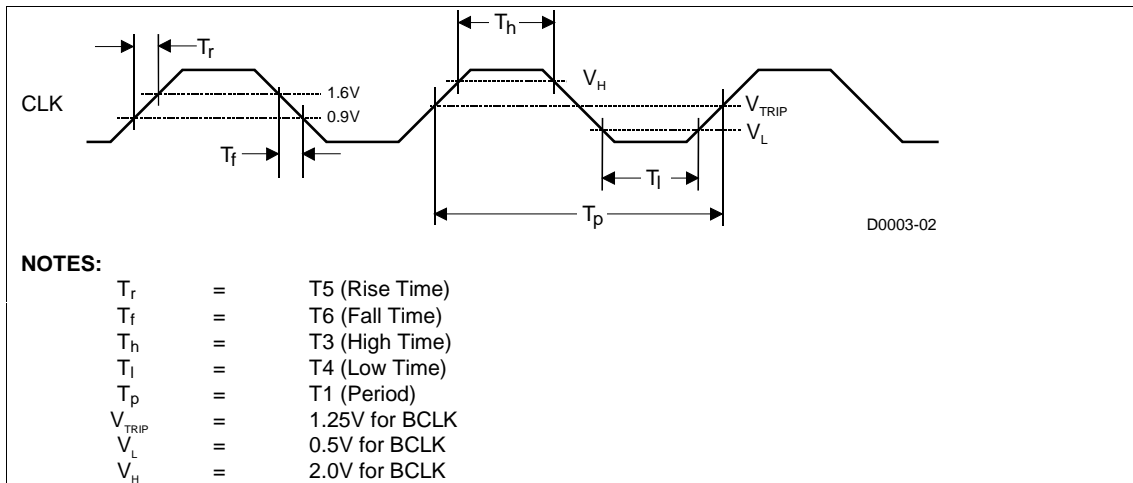
Figure 7. BCLK Timing Waveform

Symbol	Parameter	Min	Typ	Max	Unit	Figure	Notes
	System Bus Frequency		100		MHz		
T1	BCLK Period		10		ns	Figure 7	Note 2
T2	BCLK Period Stability			± 250	ps		Notes 3, 4
T3	BCLK High Time	2.70			ns	Figure 7	at >2.0V
T4	BCLK Low Time	2.45			ns	Figure 7	at <0.5V
T5	BCLK Rise Time	0.175		0.875	ns	Figure 7	(0.9V – 1.6V)
T6	BCLK Fall Time	0.175		0.875	ns	Figure 7	(1.6V – 0.9V)

1. All AC timings for GTL+ and CMOS signals are referenced to the BCLK rising edge at 1.25V. All CMOS signals are referenced at 0.75V.
2. The BCLK period allows a +0.5 ns tolerance for clock driver variation.
3. Not 100% tested. Specified by design/characterization.
4. Measured on the rising edge of adjacent BCLKs at 1.25V. The jitter present must be accounted for as a component of BCLK skew between devices.

For B0 step processors, the $V_{IH,BCLK}$ Min spec is changed to 2.0V (from 1.7V for A2 step) and $V_{IL,BCLK}$ Max spec is changed to 0.5V (from 0.7V for A2 step). Due to this, new values are specified for BCLK high and low times for B0 step processors. These modifications affect corresponding specs in Table 13, Table 14, Table 24, and Figure 7 in *Mobile Pentium® III Processor in BGA2 and Micro-PGA2 Packages datasheet* (Order Number 245302-002).
